SAFETY SUMMARY

APRIL 2025

EVENT DEBRIEF: PROP STRIKE

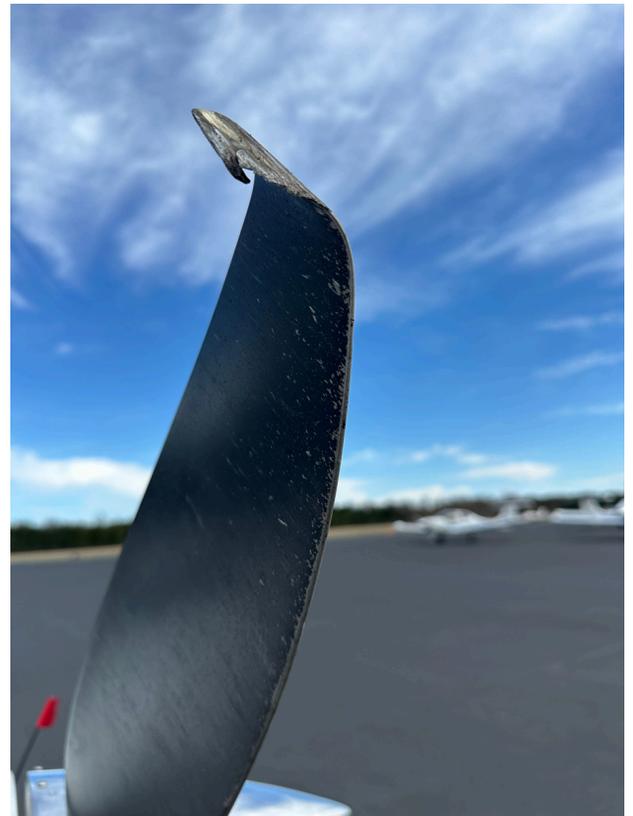
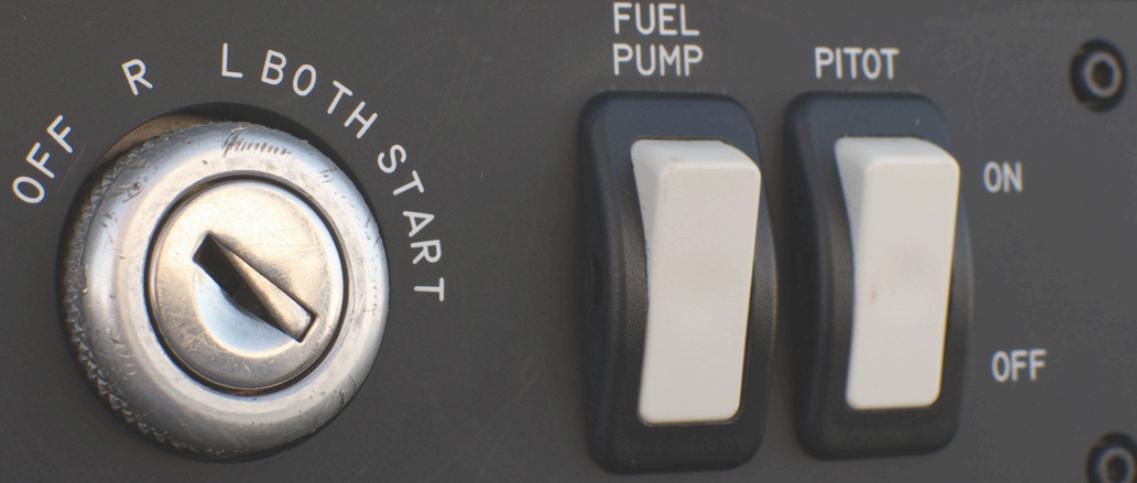
After returning from a landings flight, the instructor noticed bent propeller tips during post-flight inspection. The flight consisted of pattern work at KRNC. The student struggled with maintaining ground effect, resulting in hard landings and porpoising. The instructor initiated go-arounds when porpoising occurred and required full-stop landings when the aircraft experienced hard landings to analyze errors and corrections. The crew did not identify any indications of propeller strike or any abnormal aircraft behavior during the flight.

- Prop Strikes are not easy to identify inflight.
- The makings of a prop strike:
 - Hard impact
 - Low pitch at touchdown (roughly -4 degrees)
 - May include porpoise
- If ANY of these conditions occur, the airplane should be inspected before the flight is continued.
