SAFETY SUMMARY

OCTOBER 2025

EVENT DEBRIEF: NEAR MID AIR COLLISION

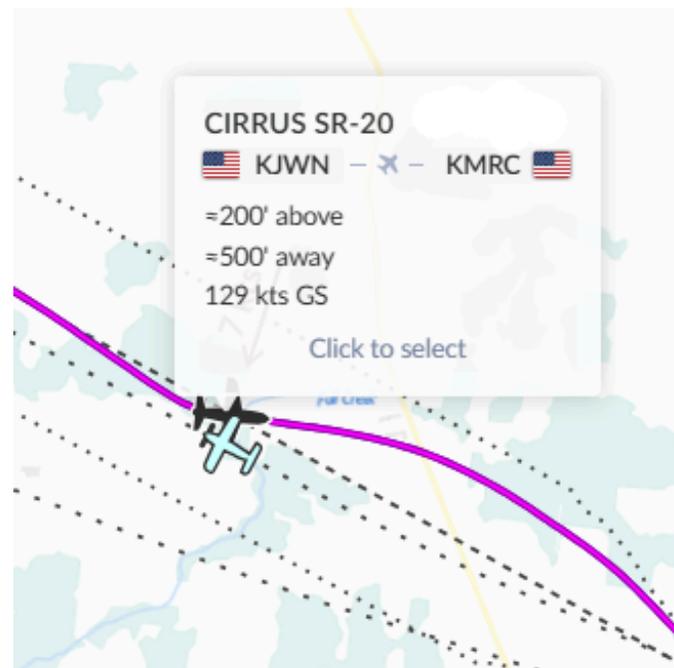
During a flight practicing Instrument Maneuvers, an instructor and student were conducting VOR navigation at 4,500 feet near the SYI VOR. While the instructor was momentarily heads-down discussing a task, they observed a Cirrus aircraft at the same altitude on a direct, closing, head-on trajectory. The instructor immediately took control, reduced power, and initiated a descending right turn to avoid the traffic. The aircraft passed an estimated 100 feet below the Cirrus.

- The MTSU aircraft was experiencing an ADS-B failure, limiting situational awareness
- The instructor's brief period of heads-down attention created a lapse in visual scanning for potential conflicts. - **Prioritize continuous visual scanning practices** during all phases of VFR training
- Consider using altitudes that are not used for cross country operations (**example: 4,300' or 3,700'**)
