SAFETY SUMMARY

FEBRUARY 2024

EVENT DEBRIEFS: WINGTIP STRIKES

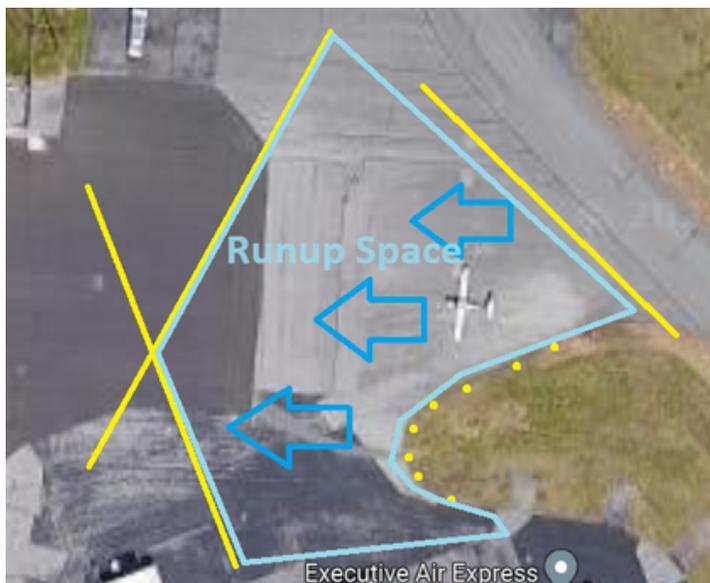
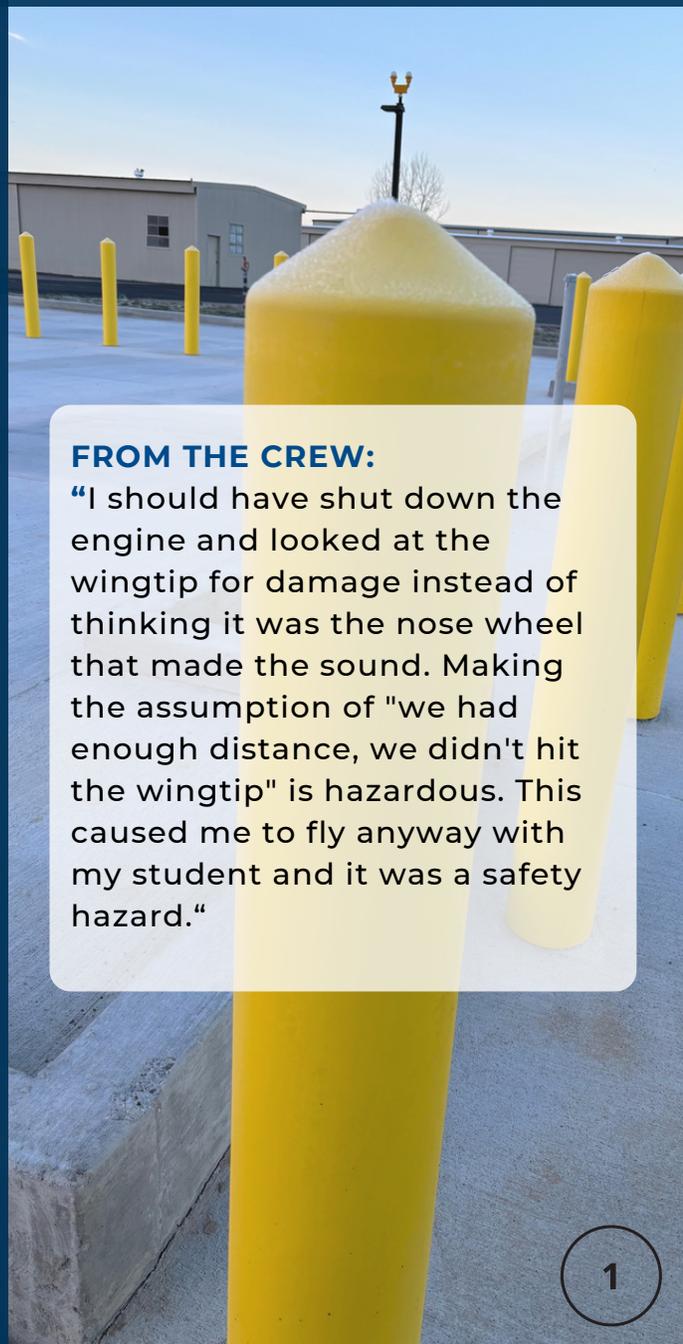
So far this semester we have had 2 aircraft taxi into the yellow poles near the south runup. In both cases, the crews got too close to the boundary of the runup area and misjudged the distance between the wingtip and the poles. Please take advantage of the full space we have. The yellow lines below mark the boundaries of the south runup.

These events resulted in damage, and in one case the crew proceeded to fly with a damaged wingtip. This could have resulted in more serious consequences. Remember, it is the PIC's responsibility to determine the aircraft is airworthy.

"I should have shut down the engine and looked at the wingtip for damage instead of thinking it was the nose wheel that made the sound. Making the assumption of "we had enough distance, we didn't hit the wingtip" is hazardous. This caused me to fly anyway with my student and it was a safety hazard."

When in doubt, shut down and exit the aircraft to examine potential damage!
