# SAFETY SUMMARY

MARCH 2024

## EVENT DEBRIEF: WINGTIP STRIKE DURING LANDING

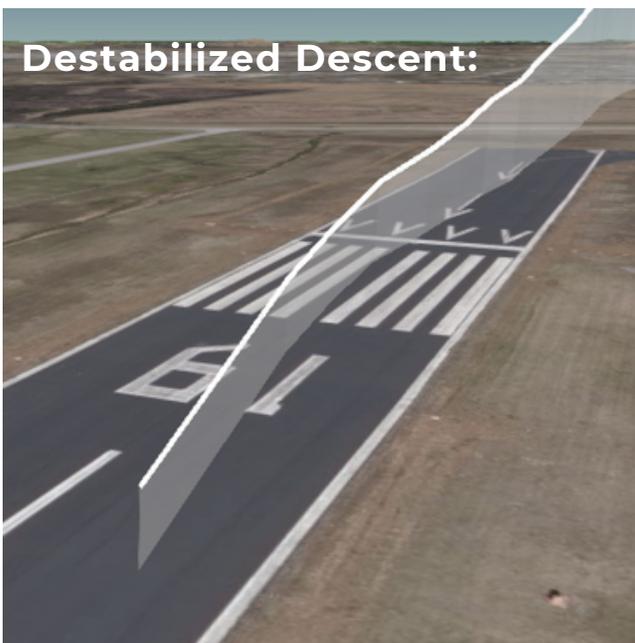
A DA40 crew struck the right wingtip on the runway surface during a simulated engine-out approach to landing. The wind caused the aircraft to drift left of centerline, and the student corrected with right aileron, causing the right wingtip to contact the runway surface. Contributing factors included slow airspeed on final, improper crosswind correction, overuse of aileron within close proximity to the ground, and delayed instructor intervention.

*"Delayed reaction, coupled with not annunciating "my controls," coupled with the wind is what I think led to this happening."*

At 200' AGL on final approach, confirm

**"200 feet, stable" or**

**"200 feet go-around."**

Go Around Criteria:

- Approach or runway is obstructed;
- <200' AGL: not on centerline, glide path, Vref, or landing configuration;
- Bounce; or
- Unable to land within first 1/3 of the runway.
