SAFETY SUMMARY

OCTOBER 2024

EVENT DEBRIEF: WINGTIP STRIKE DURING PARKING

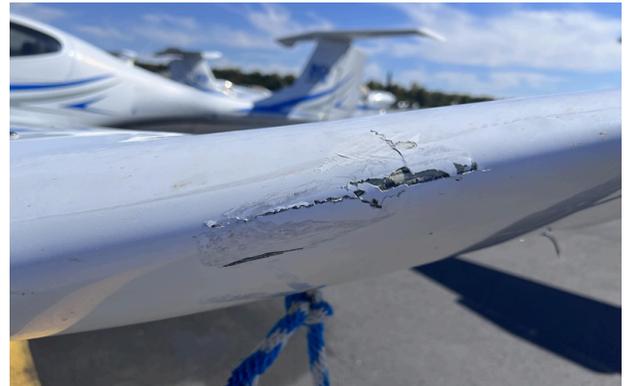
A DA40 crew was returning from an evaluation flight and taxiing to parking. The student entered the ramp too fast (8-10 kts) and too close to the adjacent parked aircraft. The left wingtip struck the nose cone and propeller of the parked aircraft. The instructor attempted to intervene, but it was too late. During the debrief the student mentioned being frustrated by the unsatisfactory outcome of the flight, which may have contributed to the event.

- Frustrations and distractions can cause us to be absent minded. The flight isn't over until the aircraft is parked and secured.
- As the instructor, I should have corrected for the close proximity to the other aircraft.
