SAFETY SUMMARY

FEBRUARY 2024

EVENT DEBRIEFS: WINGTIP STRIKES

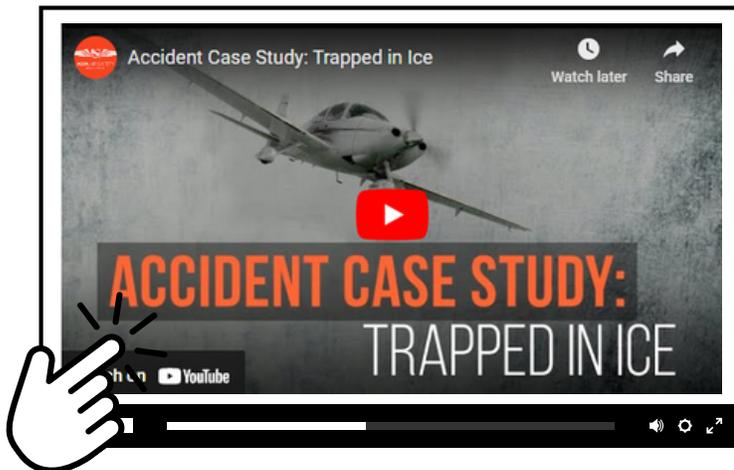
Frost and ice present a unique hazard during the cold weather months! It is imperative to remember that accumulation of ice or frost can quickly become a critical inflight emergency. Accumulation of ice on a lifting surface has the ability to **reduce lift by up to 30%** and **increase drag by up to 40%**. This leads to increasing stall speeds at lower angles of attack and decreased controllability of the aircraft. As a reminder, the **DA-40 and PA-44 are NOT approved for flight into known or forecasted icing conditions.**

Ground Ops uses a glycol solution to defrost the wings, tail, and control surfaces. It is the **PIC's responsibility** to determine that the aircraft is completely clear of frost and ice before departure.

Windshield cleaner and windshield wiper can be used to clear frost from the canopies. **Reduced visibility out of the canopies also presents an inflight hazard** and was a contributing factor in a recent MTSU wingtip strike event.
