# SAFETY SUMMARY

FEBRUARY 2026

## EVENT DEBRIEF: TRAFFIC PATTERN CONFLICT

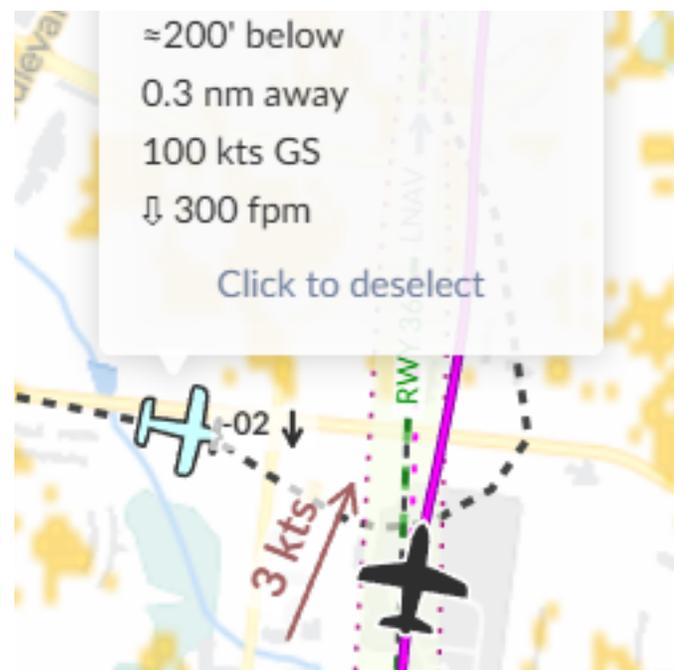
During a multi flight, a Seminole crew was returning to KMBT on an RNAV approach when a non-MTSU aircraft turned base. The MTSU crew called a 2nm final shortly before the non-MTSU aircraft called a base and turned, leading to the MTSU crew executing an immediate go-around. The non-MTSU aircraft did not have the MTSU crew in sight until they had climbed into the upwind to land through the pattern. The closest the two aircraft got was within 0.3nm laterally and 200ft vertically.

- The MTSU aircraft reported being “used to people extending downwind for RNAV traffic,” especially as they were roughly abeam the traffic that turned base.
- This event highlights the role of **expectation bias**. When pilots expect other aircraft to behave in a certain way, it can influence decision-making and delay recognition.
- Multiple aircraft were established on Downwind. It is important to remember that **VFR aircraft conducting instrument approaches do not have right of way**. If spacing becomes uncertain, breaking off and reestablishing in the pattern is the safest option.

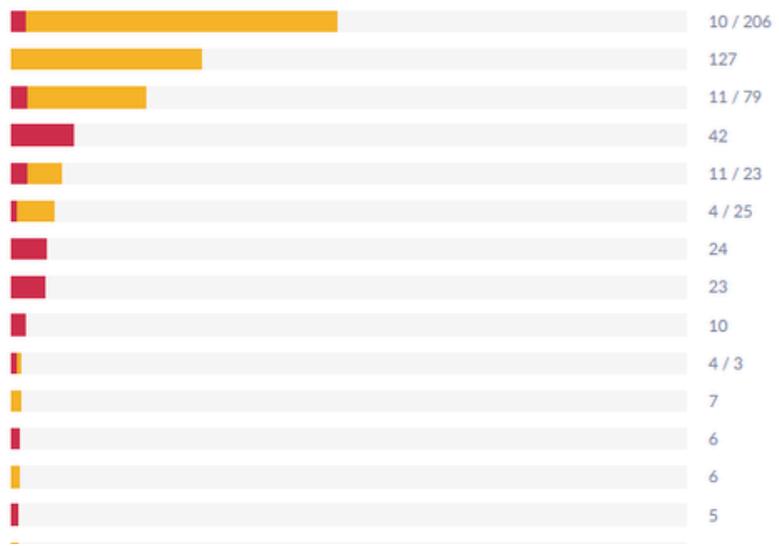
### All flags by type

- Low IAS in takeoff climb
- Side-Loaded Landing
- Low Height AGL
- Far from centerline in takeoff roll
- Traffic in proximity
- Low IAS on approach
- Approach with METAR wind gust speed > 25 kts
- Takeoff with METAR wind gust speed > 25 kts
- Near Stall <1500' AGL
- High CHT
- Low Remaining Runway at liftoff
- Traffic in straight line proximity
- High Pitch when flying low
- Far from centerline at touchdown
